APOLLO 14 MISSION REPORT

Mission Evaluation Team

April 1971

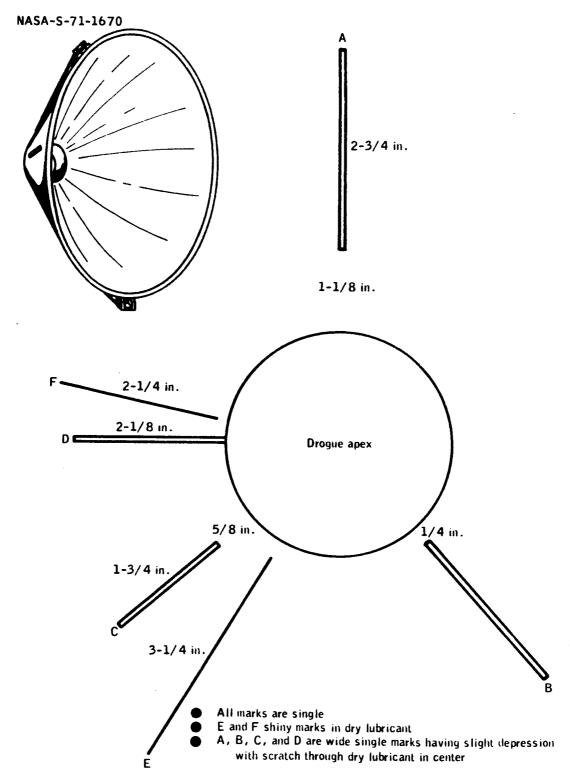
Figure 14-2.- Location of marks on drogue assembly.

- b. Each of the six marks on the drogue resulted from separate contacts by the probe head (fig. 14-2). Although three of the marks are approximately 120 degrees apart, a docking impact with locked capture latches should result in three double marks (to match the latch hooks) 120 degrees apart, and within one inch of the drogue apex or socket. Although the drogue marks could indicate that the individual capturelatch hooks were difficult to depress, such marks are not abnormal for impact velocities greater than 0.25 feet per second.

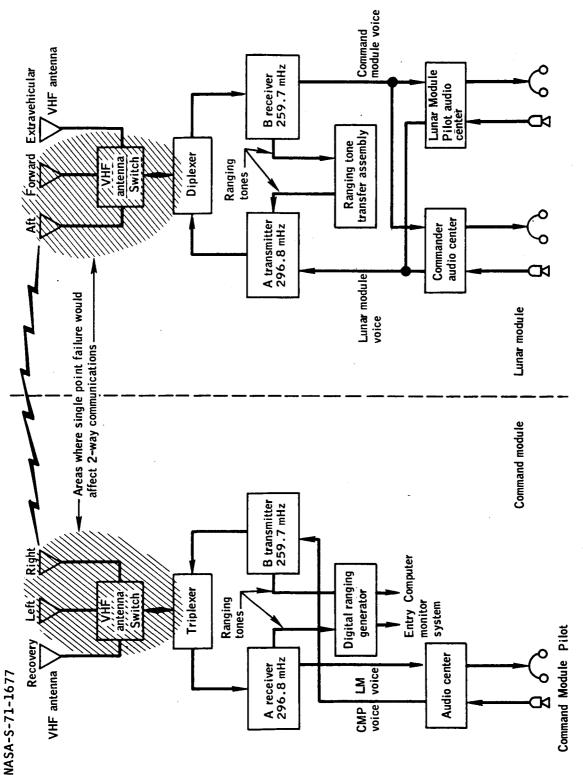
Figure 14-9.- Block diagram of VHF communications systems.

The lower-than-normal RF link performance was a two-way problem (voice was poor in both directions); therefore, certain parts of the VHF system are prime candidates for the cause of the problem. Figure 14-9 is a block diagram of the VHF communications system as configured during the rendezvous phase of the mission. Also shown are those areas in which a malfunction could have affected the two-way RF link performance. A single malfunction in any other area would have affected one-way performance only.

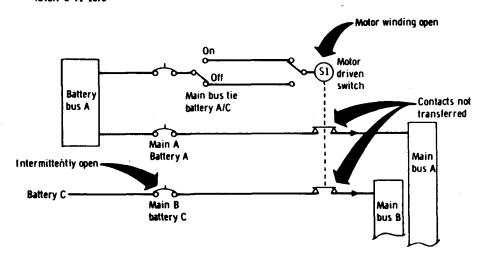
Figure 14-10.- Bus-tie circuitry.

During entry, when the main bus tie switches (motor-driven switches) were placed in the off position at 800 feet, main bus A should have deenergized; however, the bus remained on until after landing when the battery bus-tie circuit breakers were opened. Postflight testing showed that the main motor switch contacts were closed (fig. 14-10). Also, the

internal switches which control the drive motor were shorted together and the motor windings were open. These conditions indicate that the motor switch stalled.

The motor switch failure discussed in section 14.1.6 should have resulted in main buses A and B being energized after the motor switch was commanded open (fig. 14-10). Postflight continuity checks, however, showed that there was an open circuit between battery C and main bus B and that the main bus B circuit breaker for battery C was intermittent.

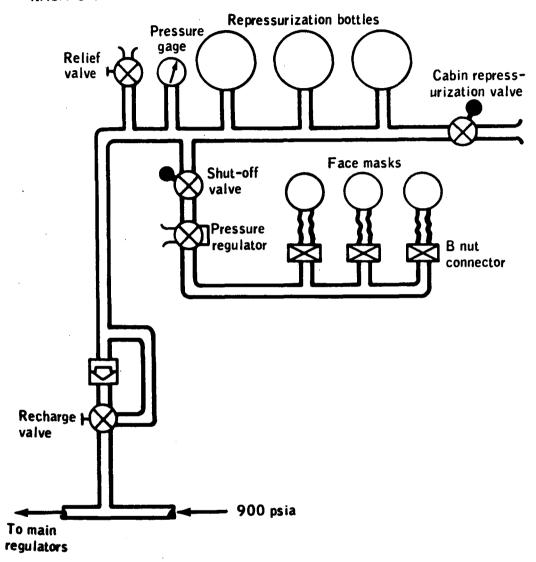
Figure 14-12.- Rapid repressurization system.

Repressurization of the three storage bottles in the rapid repressurization system (fig. 14-12) was required three times in addition to the normal repressurizations during the mission. The system required repressurization once in lunar orbit and twice during the transearth coast phase. Just prior to the first of the transearth coast repressurizations, the system had been used (face mask checks) and refilled (fig. 14-13). In this instance, the fill valve was closed before the system was fully recharged. Calculations from the surge tank pressure data indicate that the repressurization package was at approximately 510 psi at 199 hours 48 minutes and was only recharged to about 715 psi (fig. 14-13). The cabin indication of the repressurization package pressure would have indicated a higher pressure because of the temperature rise of the compressed gas. The crew noted a value of about 700 psi (due to temperature stabilization) at approximately 211 hours and recharged the system again.

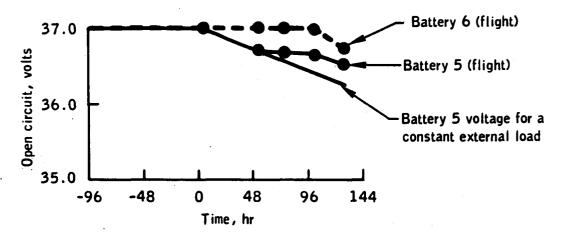
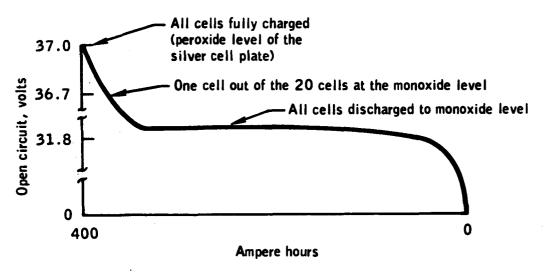
Figure 14-14.- Ascent battery voltage characteristics.

At 62 hours, the ascent battery 5 open-circuit voltage had decreased from a lift-off value of 37.0 volts to 36.7 volts instead of remaining at a constant level (fig. 14-14(a)). Figure 14-14(b) shows characteristic open-circuit voltages for a fully charged battery (peroxide level of all cells) and all cells operating on the monoxide level of the silver plate. Note that one cell at the monoxide level and the remaining 19 at the peroxide level would have caused the observed open-circuit voltage of 36.7 volts. Any one of the following conditions could have caused the voltage drop.

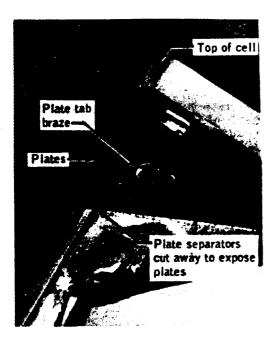
(b) Plate assembly.

A single-cell short could be caused by inclusion of conductive foreign material in the cell-plate pack at the time of manufacture or excessive braze material at the brazed joint between the plate tab and plate grid, either of which could pierce the cellophane plate separator during the launch powered-flight phase, providing a conductive path between positive and negative plates (fig. 14-15).

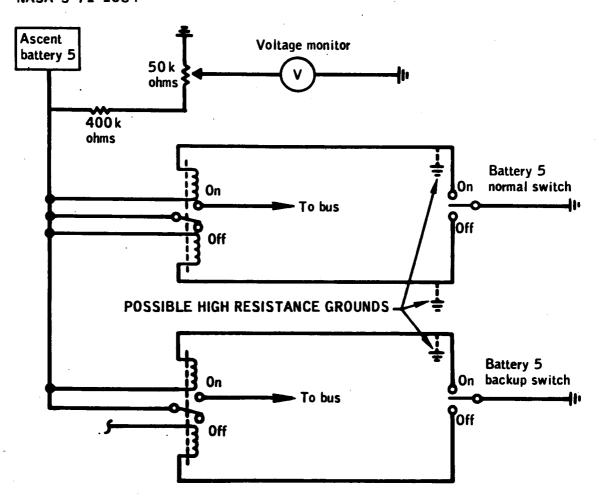
Figure 14-16.- Ascent battery 5 configured for open-circuit loads.

An external battery load could have existed from lift-off to 62 hours on the circuit shown in figure 14-16 in which typical types of high resistance shorts are also shown. For this condition, the current drain would have occurred on all cells. Figure 14-14 shows the time history of the

open-circuit bus voltage for battery 5. For a constant external load, the battery 5 open-circuit bus voltage would have been lower than the flight data at 141 hours. Therefore, the external load would have had to change with time.

To reduce the possibility of recurrence, corrective action has been taken for each of the possible causes. Stricter inspection and improved procedures have been incorporated for installation of the plugs. Particular attention will be given to the assembly of the cell plates on future units. In addition, a test has been added at the launch site to measure lunar module parasitic loads prior to battery installation to insure that no abnormal loads are present.

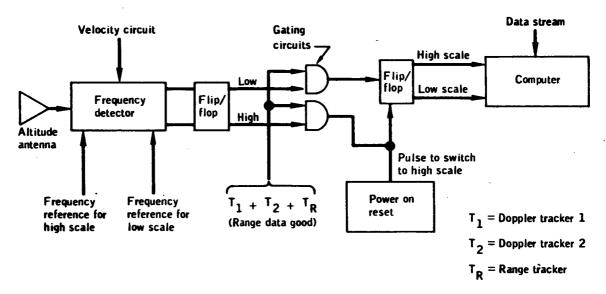
Figure 14-21.- Landing radar scale switching logic.

Two conditions occurred during the landing radar operation which were not expected; however, they were not abnormal. The first condition occurred approximately 6 minutes after initial actuation of the landing radar. The system switched to the low-range scale, forcing the trackers into the narrow-band mode of operation. This was corrected by recycling the main power circuit breaker which switched the radar to high scale. Figure 14-21 shows the radar scale switching logic. The radar then locked on and "velocity-data-good" and "range-data-good" indications were transferred to the computer. The "velocity-data-good" signal is generated when the Doppler trackers lock on and the "range-data-good" signal is generated when the range tracker also locks on.

The scale switching occurred at a slant range of 63 000 feet with a beam 4 velocity of 3000 ft/sec at an incidence angle of 35.4 degrees. Operating the landing radar under these conditions exceeds the maximum range measurement design limit (fig. 14-23). Under these conditions, the receiver is sweeping with maximum gain and the system will be sensitive to any received noise. A test was performed with a radar operating under the Apollo 14 conditions (two range-rate beams locked up and the range beam unlocked). By inserting low-level noise for a fraction of a second into the receiver, range scale switching occurred.

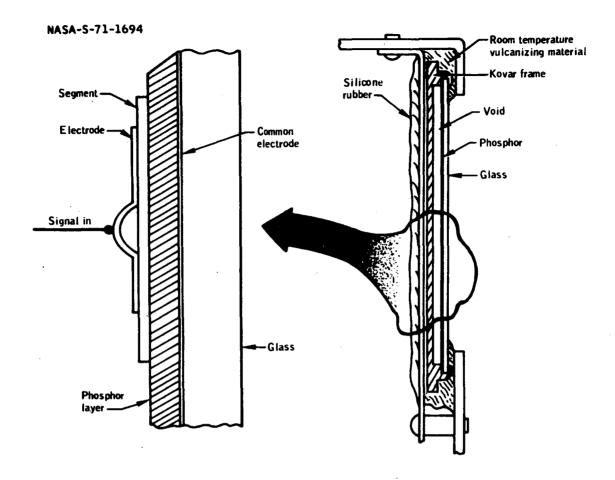
Figure 14-26.- Cross section of data entry and display assembly glass.

The crew reported a crack in the glass across the address register of the data entry and display assembly. Figure 14-25 shows the assembly and the location of the crack. Figure 14-26 is an enlarged drawing of the glass and associated electroluminescent segments.

The cause of the crack is unknown. Glass cracks have not occurred since a revision was made to the procedure used to mount the glass to the faceplate of the data entry and display assembly. The assembly is qualified for an environment in excess of the flight conditions. Therefore, either excessive internal stresses (under normal conditions) were built into the glass, or the mounting was improper (not as designed), or the glass was inadvertently hit.

Corrective action consists of applying a clear plastic tape prior to flight on the glass of the electroluminescent windows above the keyboard (fig. 14-25), like that previously used on the mission timer windows. The tape is to prevent dislodging of any glass particles if cracks occur in the future, as well as help prevent moisture from penetrating

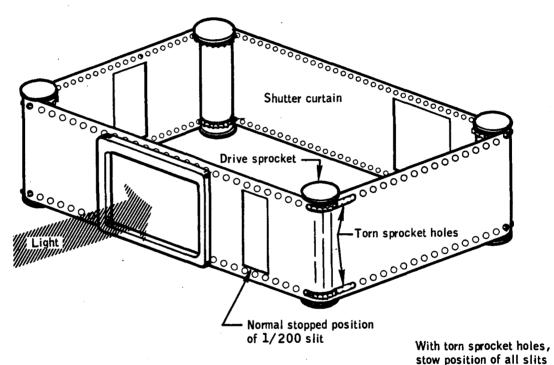
Figure 14-28.- Lunar topographic camera film track.

loose piece of aluminum 0.130 inch by 0.008 inch, which was foreign to the transistor material. With a shorted transistor, 28 volts is applied continuously to the shutter drive circuit, causing continuous shutter operation, independent of the intervalometer and independent of the single, auto, or standby mode selections. The sprocket holes in the 1/200 slot in the shutter curtain were torn as a result of the prolonged, continuous, high-speed shutter operation (fig. 14-28).

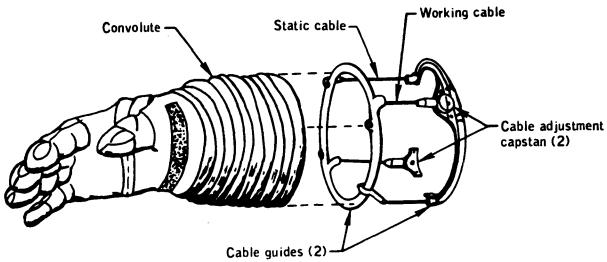
Figure 14-29. - Extravehicular glove wrist control.

After suit pressurization for the second extravehicular activity, the Lunar Module Pilot reported that his right glove had pulled his hand to the left and down and that he had not had this trouble during the first extravehicular activity period. The condition was a nuisance throughout the second extravehicular activity period. Initial indications from the Lunar Module Pilot were that a cable had broken in the glove (fig. 14-29).

A detailed examination of the returned glove, together with chamber tests, have shown that there are no broken cables and that there is free operation of the glove wrist-control cable system. However, with the Lunar Module Pilot in the pressurized flight suit, the glove took the position which was reported during the mission.

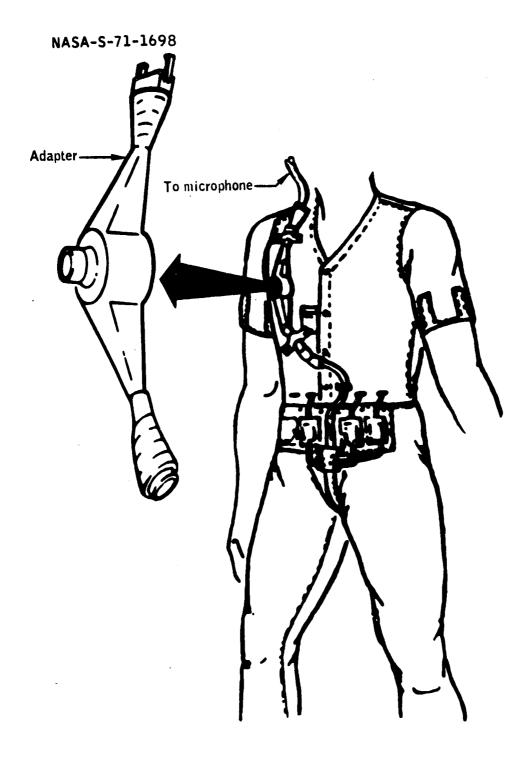
Figure 14-30.- Constant wear garment communications harness.

At approximately 29 hours, Mission Control had difficulty in communicating with the Commander. The Commander replaced his constant wear garment electrical adapter (fig. 14-30) with a spare unit, and satisfactory communications were reestablished.

The most likely cause of the problem was poor contact between connectors because of small contaminants or improper mating of a connector, which was corrected when the spare adapter was installed.

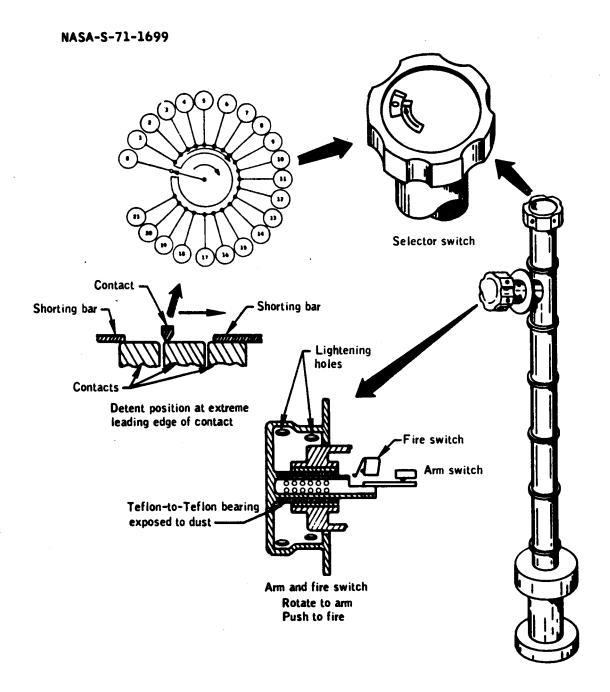
Figure 14-31.- Active seismic experiment.

The most likely causes of the problem are associated with the detent portion of the selector switch (fig. 14-31) and dirt on the firing switch actuator bearing surface. The selector switch dial can reposition out of detent in the course of normal handling because of the lack of positive seating in the detent for each initiator position. For an initiator to be fired, the selector switch must provide contact to the proper unfired initiator position. Examination of the qualification unit has shown that the detent is positioned at the leading edge of the contact surface so that any movement toward the previous position will break the contact. Also, the lightening holes in the firing switch knob make it possible for dirt to get onto the Teflon bearing surfaces, temporarily increasing the force required to close the switch (fig. 14-31).

Corrective action for Apollo 16 consists of adding a positive detent mechanism, properly aligned with the selector switch contacts, and dust protection for the firing switch actuator assembly. The thumper is not carried on Apollo 15.

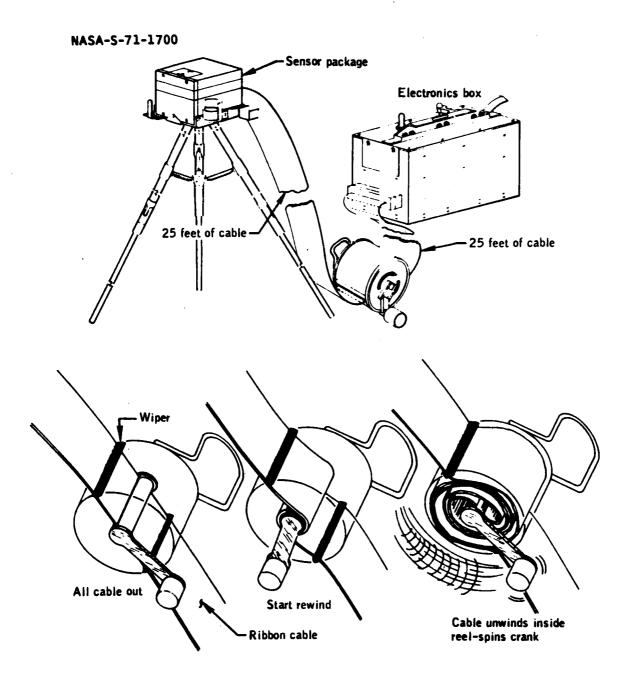
Figure 14-32.- Lunar portable magnetometer cable reel.

The crew reported that it was difficult to rewind the lunar portable magnetometer cable. The cable is deployed and rewound at each location where the lunar portable magnetometer is used (fig. 14-32).

The lunar portable magnetometer ribbon cable snarls easily at 1/6g and is difficult and tedious to unsnarl. If it is necessary to remove the hand from the crank to unsnarl the cable during the first part of rewinding the cable, the cable will unwind within the reel and spin the reel handle (fig. 14-32). Free unwinding of the reel is required during deployment; however, it is desirable to be able to lock the reel against rotation at times during rewind of the cable. Rewinding was difficult because there was no provision to lock the reel during rewind, and gripping the reel and crank was difficult with the gloved hand.

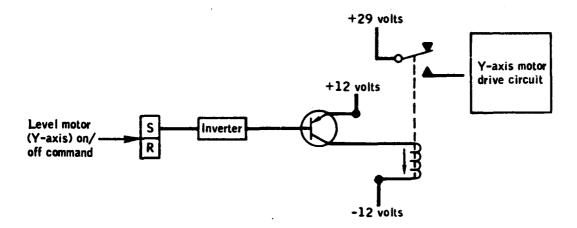
Figure 14-33.- Y-axis leveling motor circuitry.

The horizontal Y-axis leveling motor of the gimbal leveling system operates intermittently (fig. 14-33). Although a command verification is received when commands are sent, power is not necessarily received by the motor. When there is an indication of power to the motor, the motor does operate. As a result, during the first lunar day, response to ground commands was normal except for 6 of the 22 commands when there was no response.

The problem is caused by an intermittent component in the motor control circuit (fig. 14-33). There is no correlation between the occurrence of the problem and the temperature of the lunar surface, the central station electronics, or the experiment. Whenever there is an indication of power to the motor, the motor operates. When the motor operates, it operates properly and pulls the normal current.

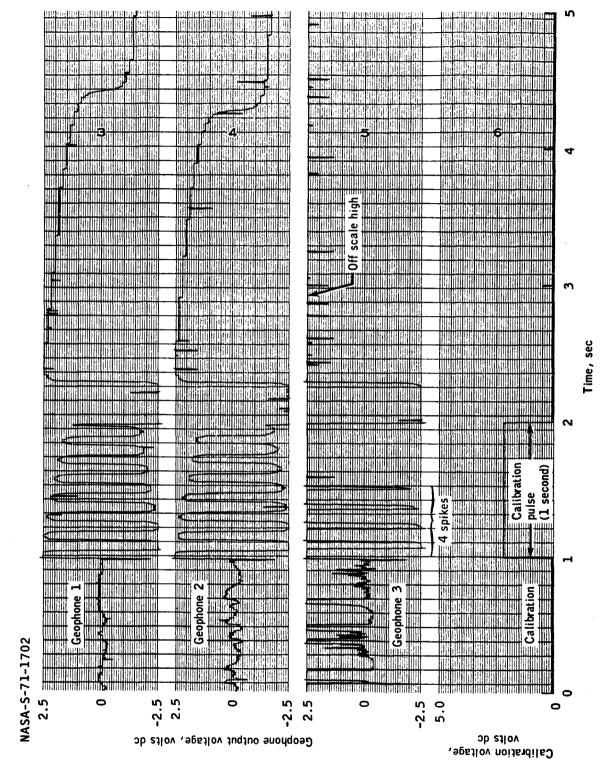
Figure 14-34. - Geophone calibration data.

The experiment was turned on in the listening mode on March 26, 1971, and geophone 3 data were spiking off-scale high (fig. 14-34). When the geophone channels were calibrated, the geophone 3 channel went off-scale high simultaneously with the start of the calibration pulse and stayed off-scale high for the remainder of the listening period. During the 1-second period when the calibration pulse was present, data from geophones 1 and 2 showed the normal 7-hertz ringing caused by the calibration pulse. However, geophone 3 data showed four negative-going spikes coincident with the first four negative half cycles of the ringing on the other two channels. The spikes decreased in duration from the first to the last, the last having an amplitude of 90 percent of

full scale (plus 2.5 volts to minus 2.0 volts). During the time that this pulse was present, the signal on channel 2 changed from minus 2.2 volts to minus 2.35 volts, indicating that channel 3 was operating at an apparent gain of 30 times the channel 2 gain.

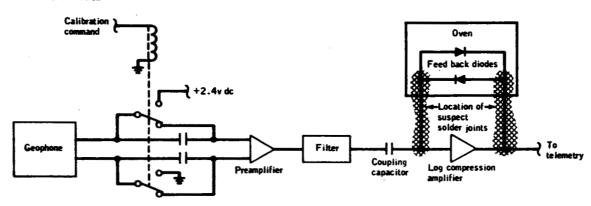
Figure 14-35.- Typical geophone channel.

It is believed that the failure is in the logarithmic compression amplifier because signals are coupled into it through an input coupling capacitor. This capacitor would block any offset voltages from the preceding stages which would be required to drive the output off-scale high. Analysis indicates that the most probable cause of the problem is an intermittent open circuit in the diode feedback path. This would allow the amplifier input transistor to saturate, driving the output off-scale high. When signals large enough to drive the input stage out of saturation were present, the output would then respond and the output signal would not be compressed.

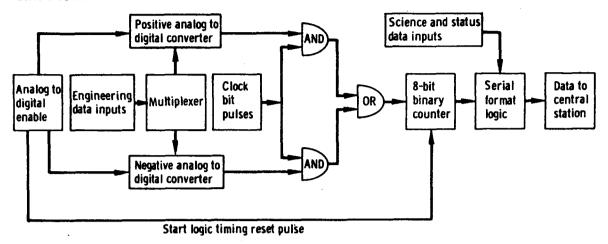
Figure 14-37.- Simplified data logic control.

An intermittent failure of the start reset pulse for the positive log analog-to-digital converter control logic (fig. 14-37) could cause the problem. Although the failure permits the positive converter initial output to fill the eight-bit binary counter and produce a full-scale reading; thereafter, when a start pulse for the positive converter should reset the eight-bit counter, it fails to do so, and the negative word which is still in the counter is read out as a positive word. The cause appears to be an intermittent component or wire connection in one of the associated modules. However, it does not appear to be a function of the temperature. The components have been passed by normal high reliability screening, and systems tests have included operational pressure, temperature, vibration, humidity, and accelerated lunar environment cycles. No failure of this

type has been experienced with ground tests. No additional testing is considered warranted for Apollo 15, which will be the last mission for the experiment.

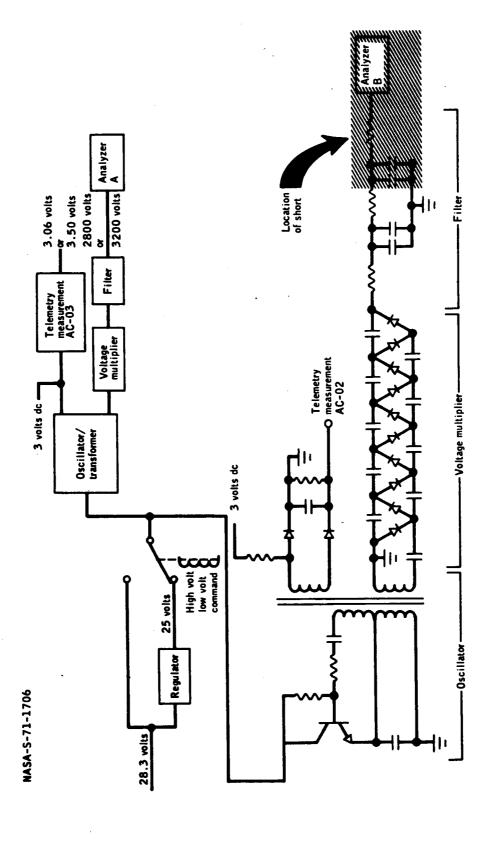
Figure 14-38.- Analyzer power supplies.

The voltage measurement reading on the analyzer B power supply (fig. 14-38) became erratic on April 8, 1971, and the analyzer B science data were lost.

On April 10 and 16, the experiment was commanded on to normal (low-voltage) mode, and to increase (high-voltage) mode in a series of tests. The results indicate that the plus 28-volt input, the regulator, and the analyzer A power supply were functioning properly, and that the problem was in the analyzer B power supply.
